Additional test report of a fire resistance test utilising the general principles of BS 476: Part 20: 1987 on four specimens of wall and four specimens of floor mounted linear gap seals

184237

Arabian Vermiculite Industries

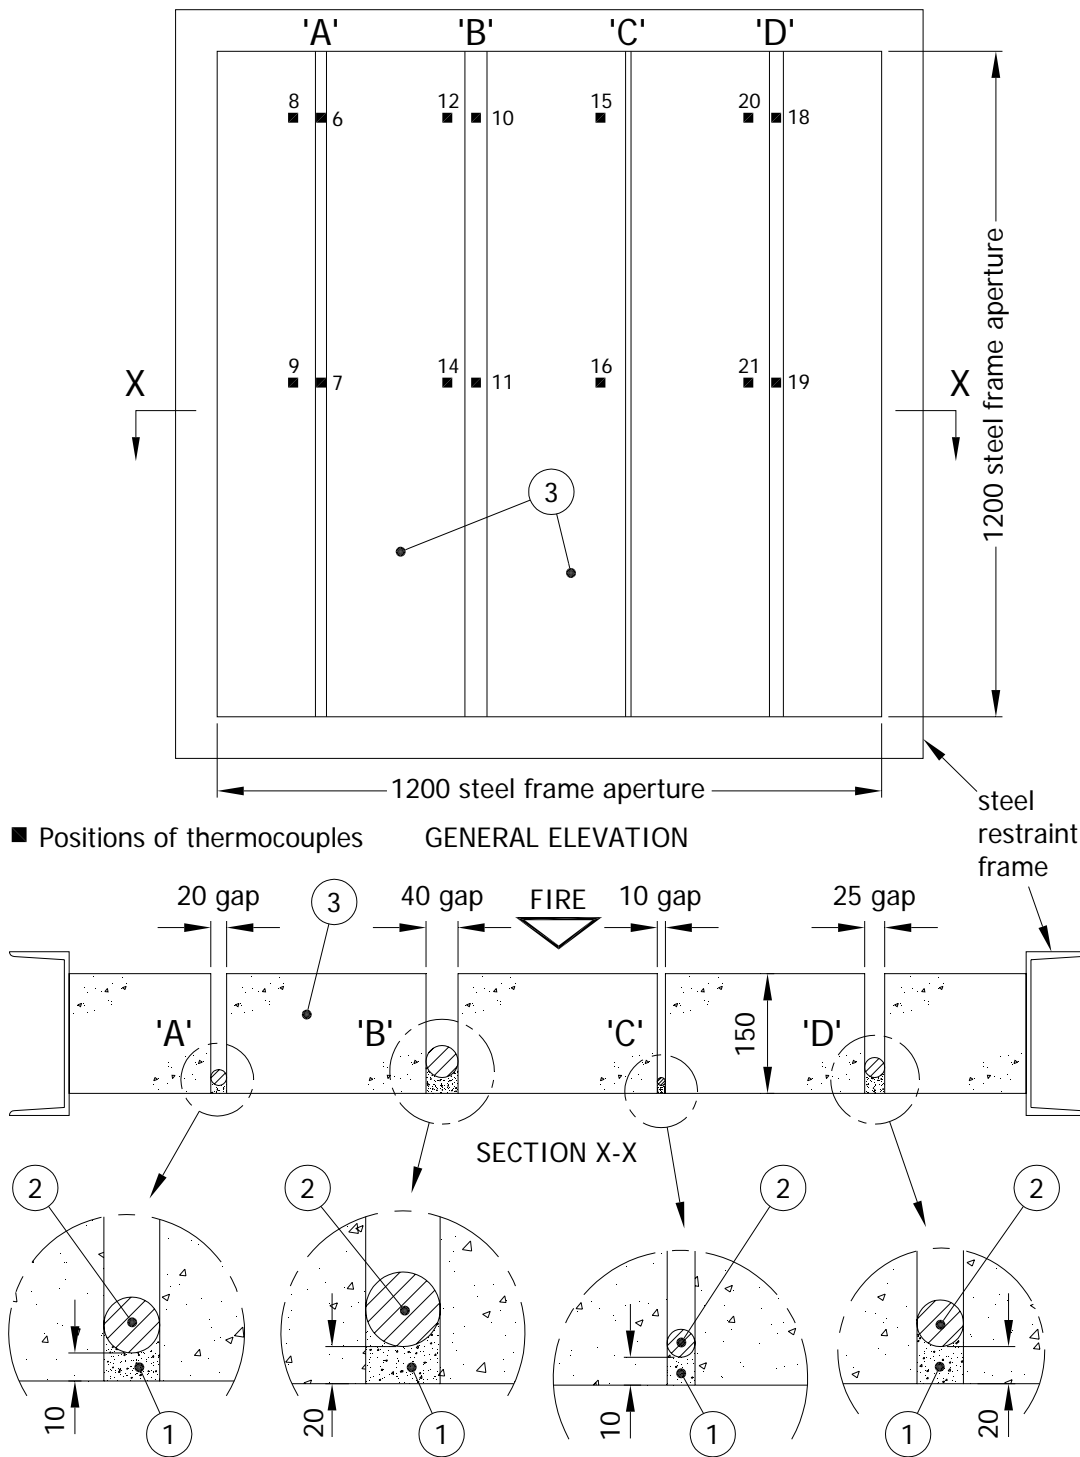
Figure 1- General Elevation of Wall Specimens and Unexposed Face Thermocouples

The section of wall had overall dimensions of 1000 mm long by 1000 mm wide by 250 mm thick and was provided with four linear joints, referenced Specimens A, B, C, and D. The section of floor had overall dimensions of 1200 mm high by 1200 mm wide by 250 mm thick and was provided with four linear joints, referenced Specimens E, F, G, and H.

Do not scale. All dimensions are in mm

General	The instrumentation and measuring equipment provided was in accordance with BS 476: Part 20: 1987 and the draft European document, where appropriate.
Furnace	The furnace was controlled so that its mean temperature complied with the requirements of BS 476: Part 20: 1987, Clause 3.1, using four mineral insulated thermocouples distributed over a plane 100 mm from the surface of the wall construction.
Thermocouple Allocation	<p>Thermocouples were provided to monitor the unexposed surface of the specimens and the output of all instrumentation was recorded at no less than one minute intervals as follows:</p> <p>At a minimum of two positions on the surface of the sealant material of each specimen, one nominally 100 mm from each end and one at mid span. All positioned at nominally mid-width.</p> <p>At a minimum of two positions on the surface of the wall and floor assembly, 25 mm away from the edge of each seal and adjacent to the positions of the thermocouples on the surface of the sealant.</p> <p>The locations and reference numbers of the various unexposed surface thermocouples are shown in Figure 1.</p>

i. Specimen 'A' & 'E'	: 20 mm x 10 mm
ii. Specimen 'B'	: 40 mm x 20 mm
iii. Specimen 'C'	: 10 mm x 10 mm
iv. Specimen 'D'	: 25 mm x 20 mm
v. Specimen 'F'	: 50 mm x 25 mm
vi. Specimen 'G'	: 10 mm x 6 mm
vii. Specimen 'H'	: 25 mm x 15 mm
Application method	: Cartridge gun
Application rate

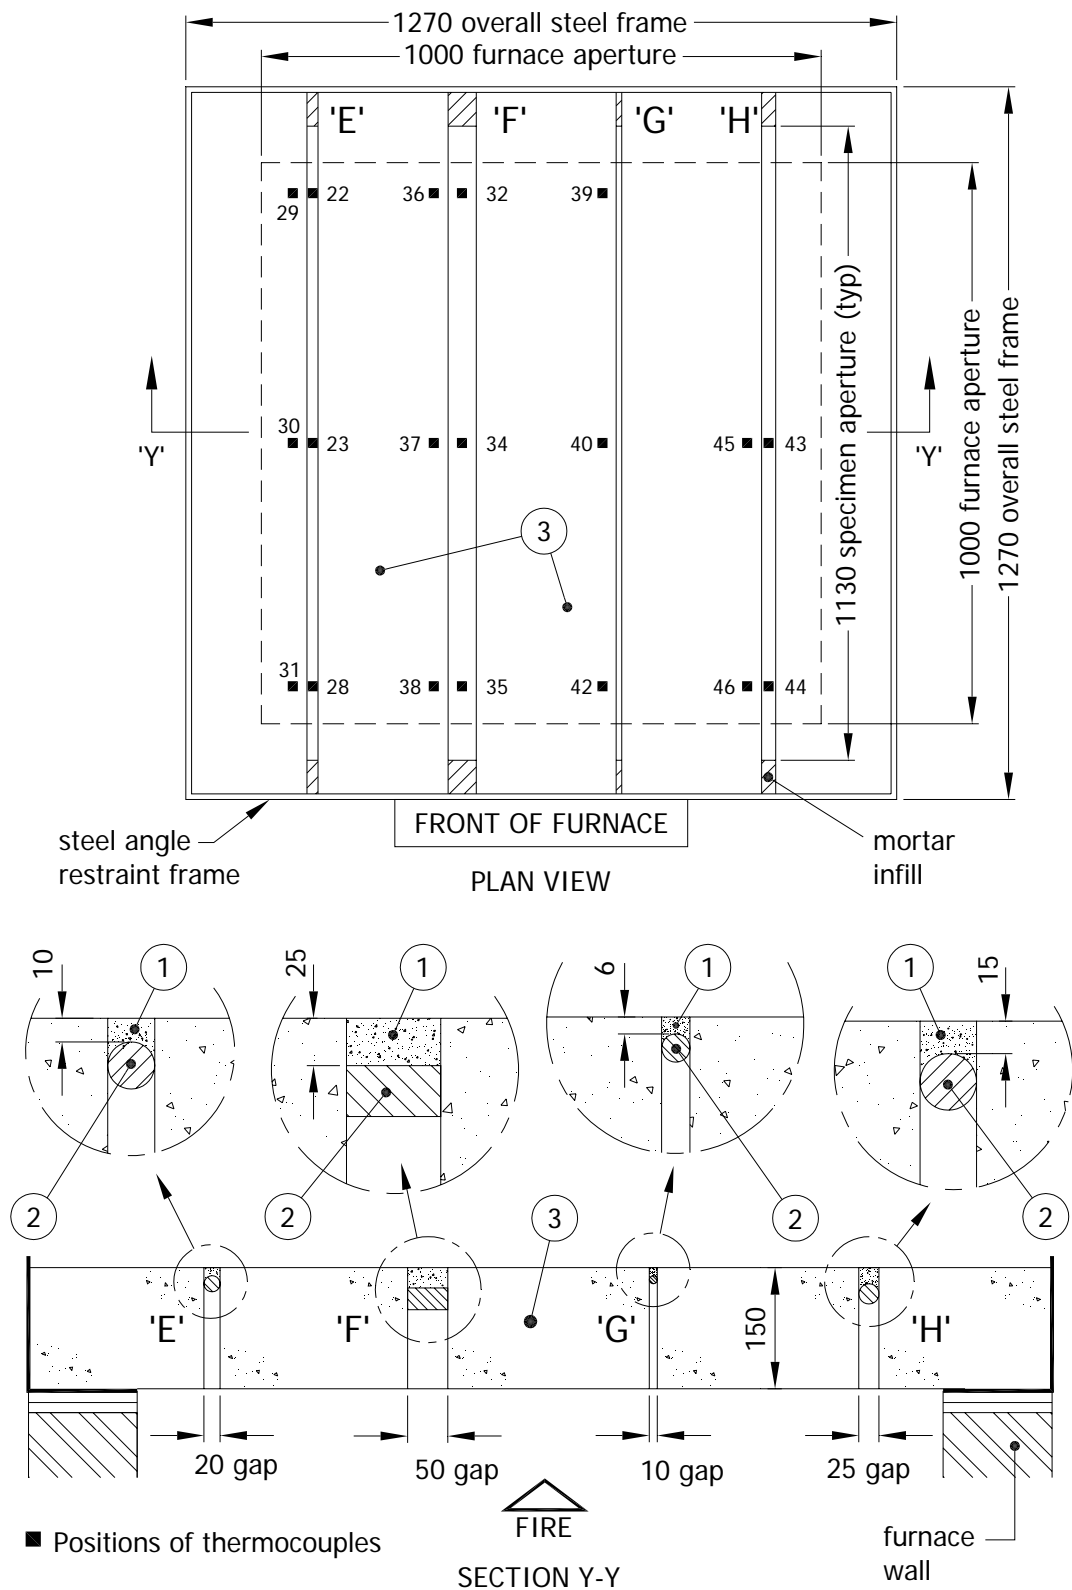
Figure 2 – General Plan of Floor Specimens and Unexposed Face Thermocouples

Do not scale. All dimensions are in mm

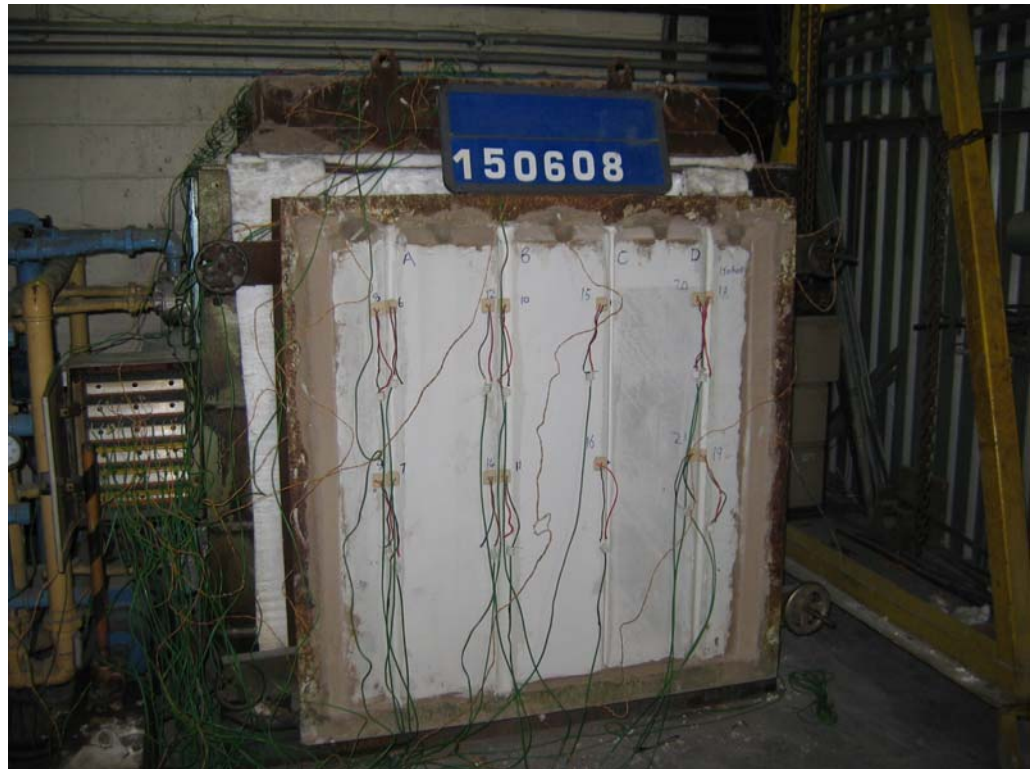
The unexposed face of the wall construction prior to testing

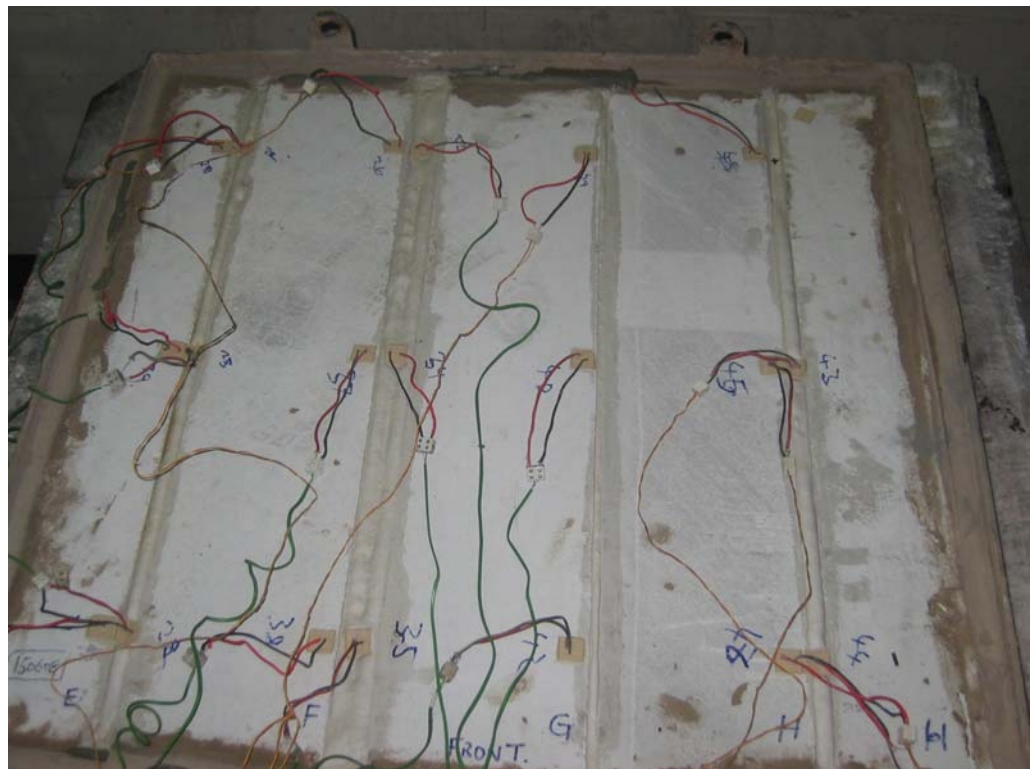
The unexposed face of the floor construction prior to testing

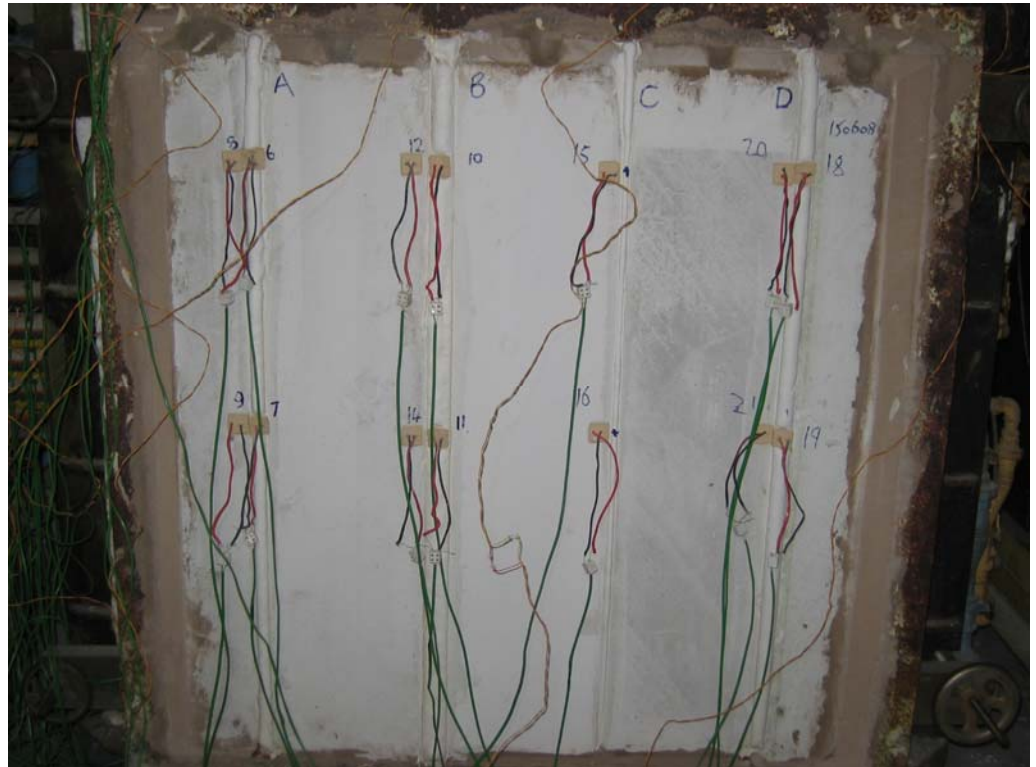
The unexposed face of the wall construction after 120 minutes of testing

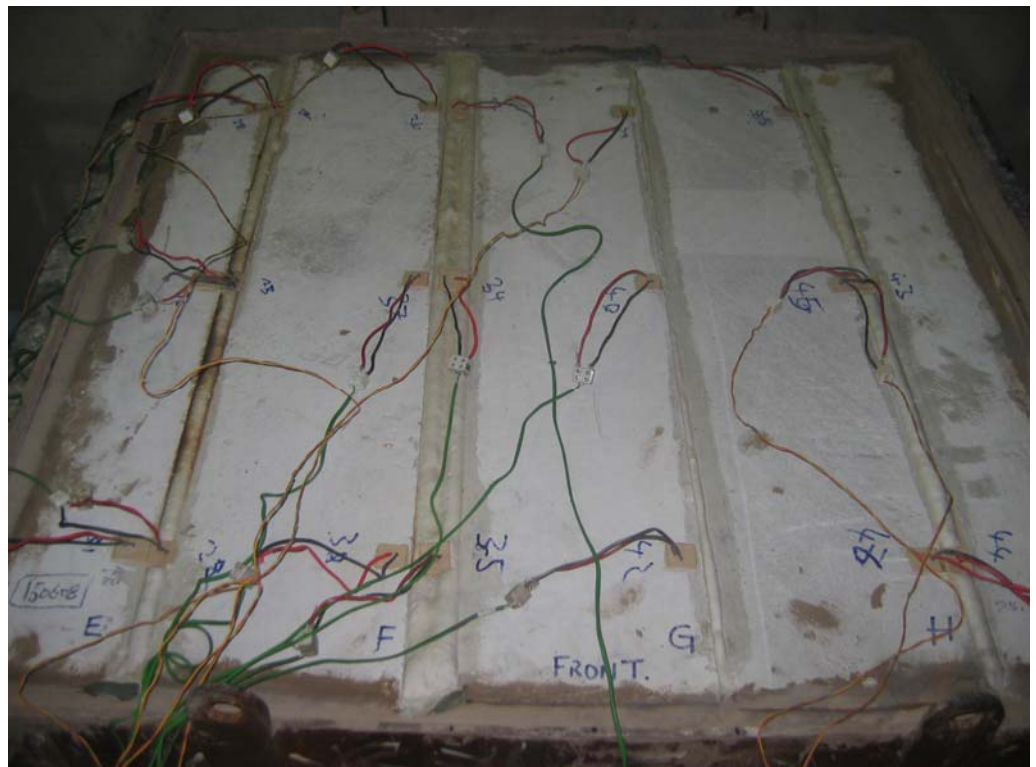
The unexposed face of the floor construction after 120 minutes of testing

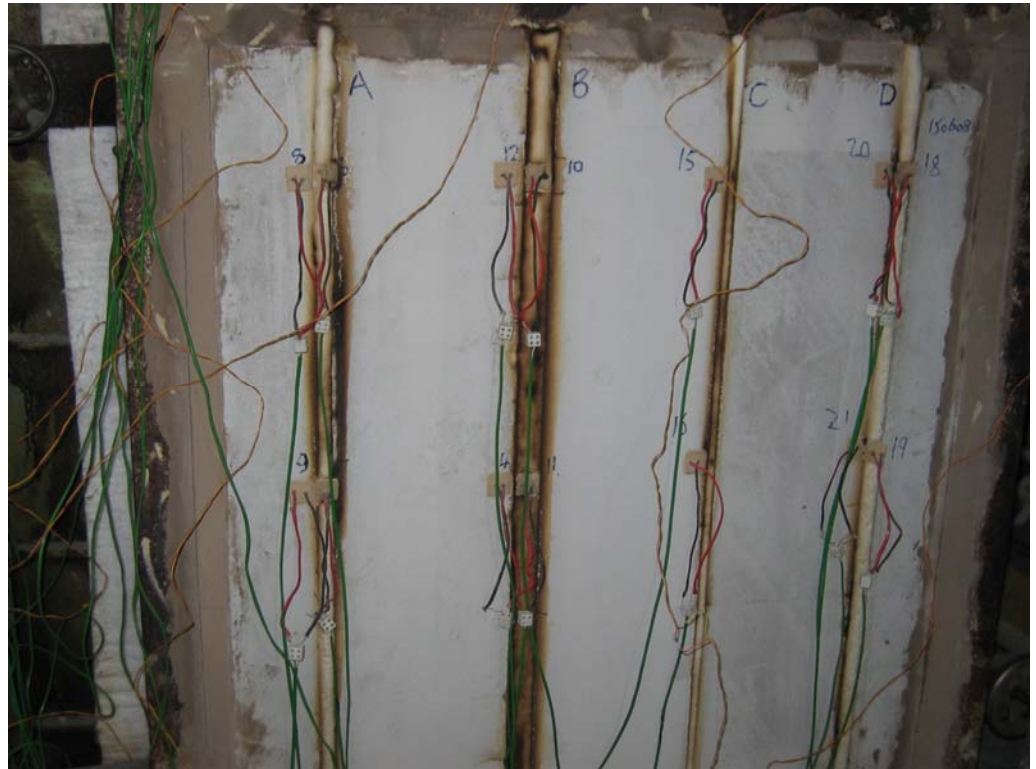
The unexposed face of the wall construction after 240 minutes of testing

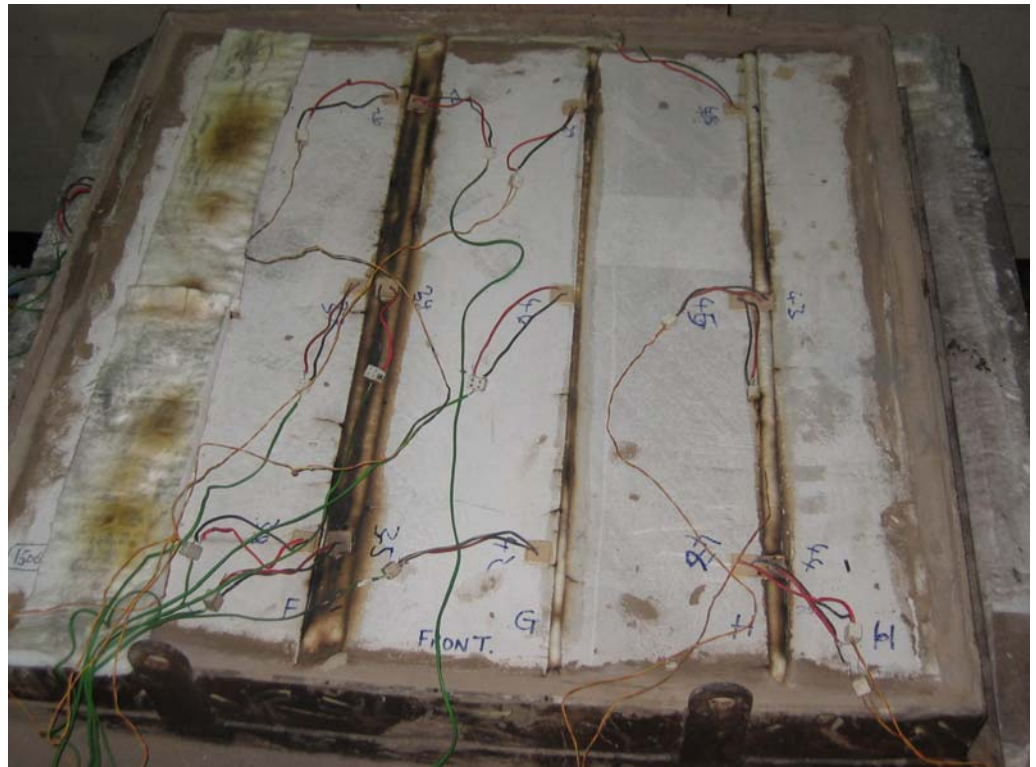
The unexposed face of the floor construction after 240 minutes of testing

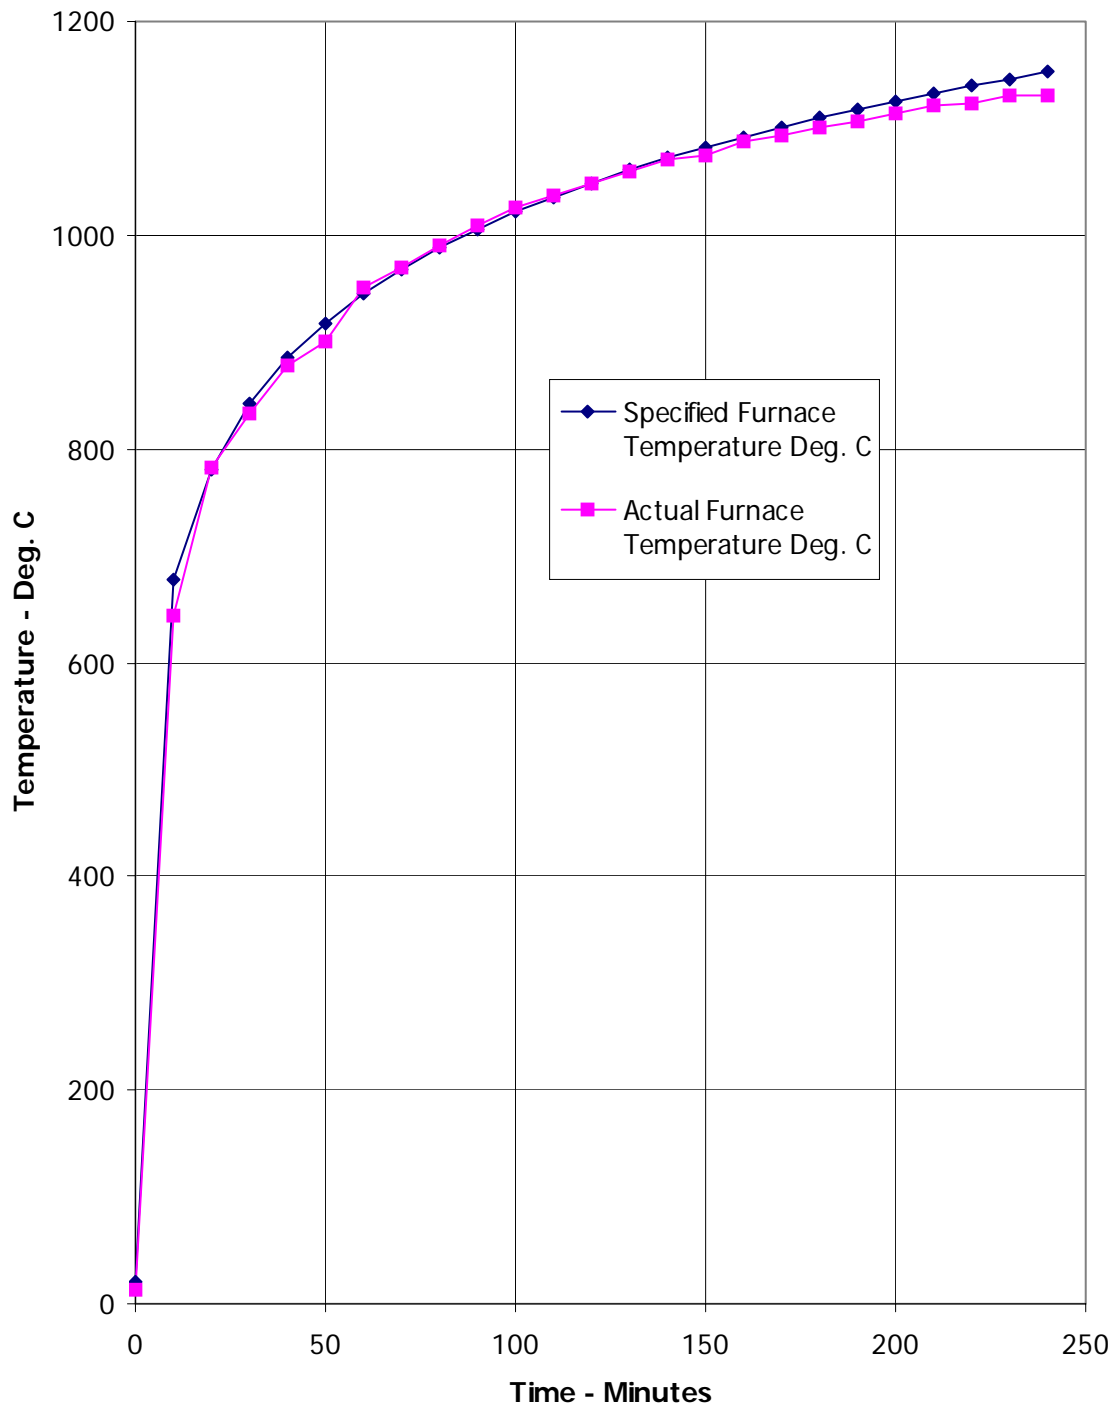
Graph Showing Mean Furnace Temperature, Together With The Temperature/Time Relationship Specified In The Standard

Time Mins	Specified Furnace Temperature Deg. C	Actual Furnace Temperature Deg. C
0	20	13
10	678	643
20	781	782
30	842	834
40	885	878
50	918	901
60	945	951
70	968	970
80	988	991
90	1006	1009
100	1022	1026
110	1036	1037
120	1049	1048
130	1061	1059
140	1072	1071
150	1082	1075
160	1092	1087
170	1101	1094
180	1110	1100
190	1118	1107
200	1126	1115
210	1133	1121
220	1140	1123
230	1146	1130
240	1153	1131
